PENNSYLVANIA
**LICKING CREEK DAM—
CLEARVIEW RESERVOIR**

PHASE I INSPECTION REPORT

NATIONAL DAM INSPECTION PROGRAM

NAME OF DAM: Licking Creek Dam (Clearview Reservoir)
STATE LOCATED: Pennsylvania
COUNTY LOCATED: Juniata
STREAM: Licking Creek
DATE OF INSPECTION: October 26, 1978

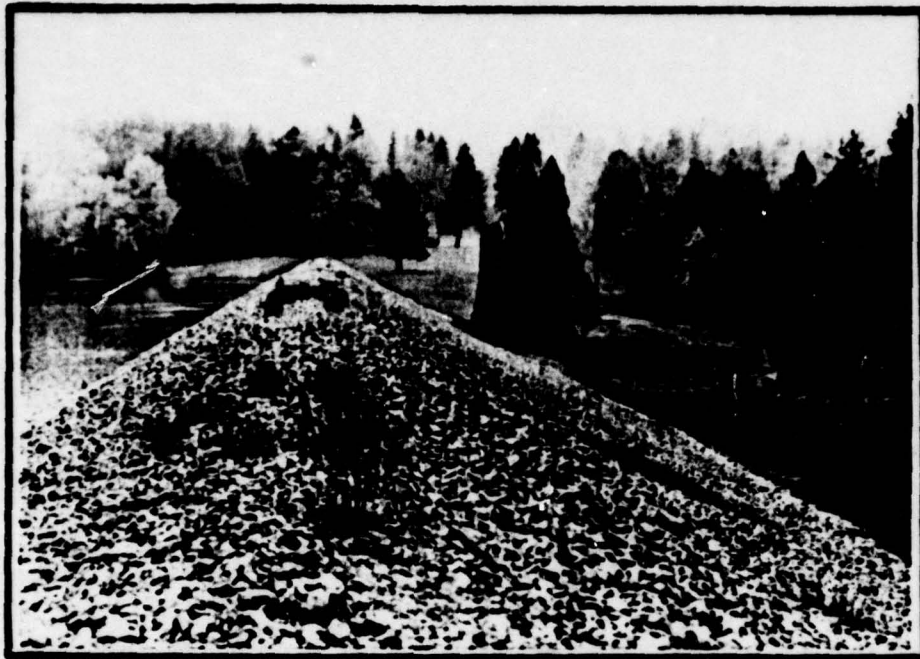
Overview from right abutment.

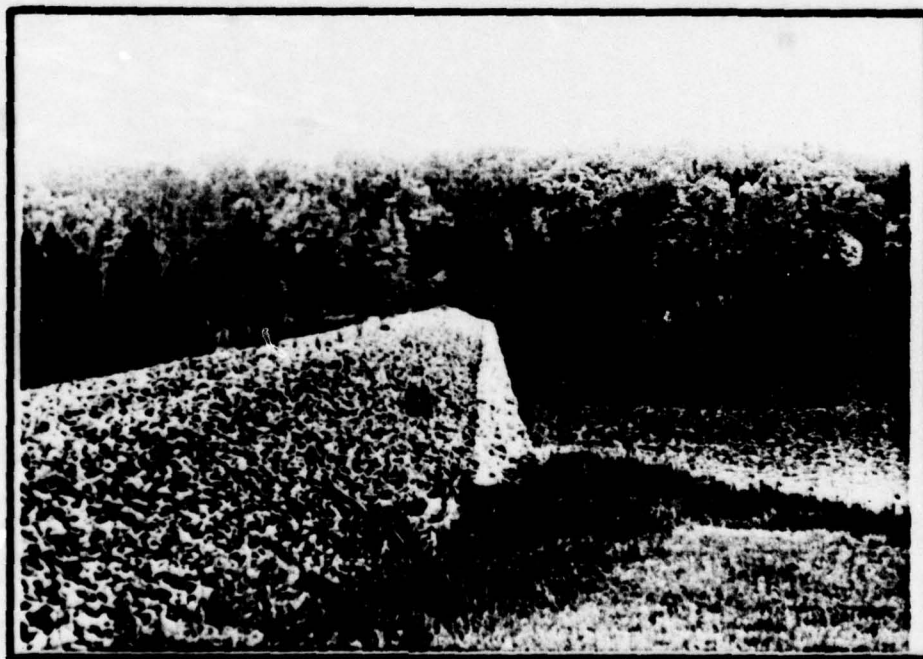
Upstream slope from left abutment.

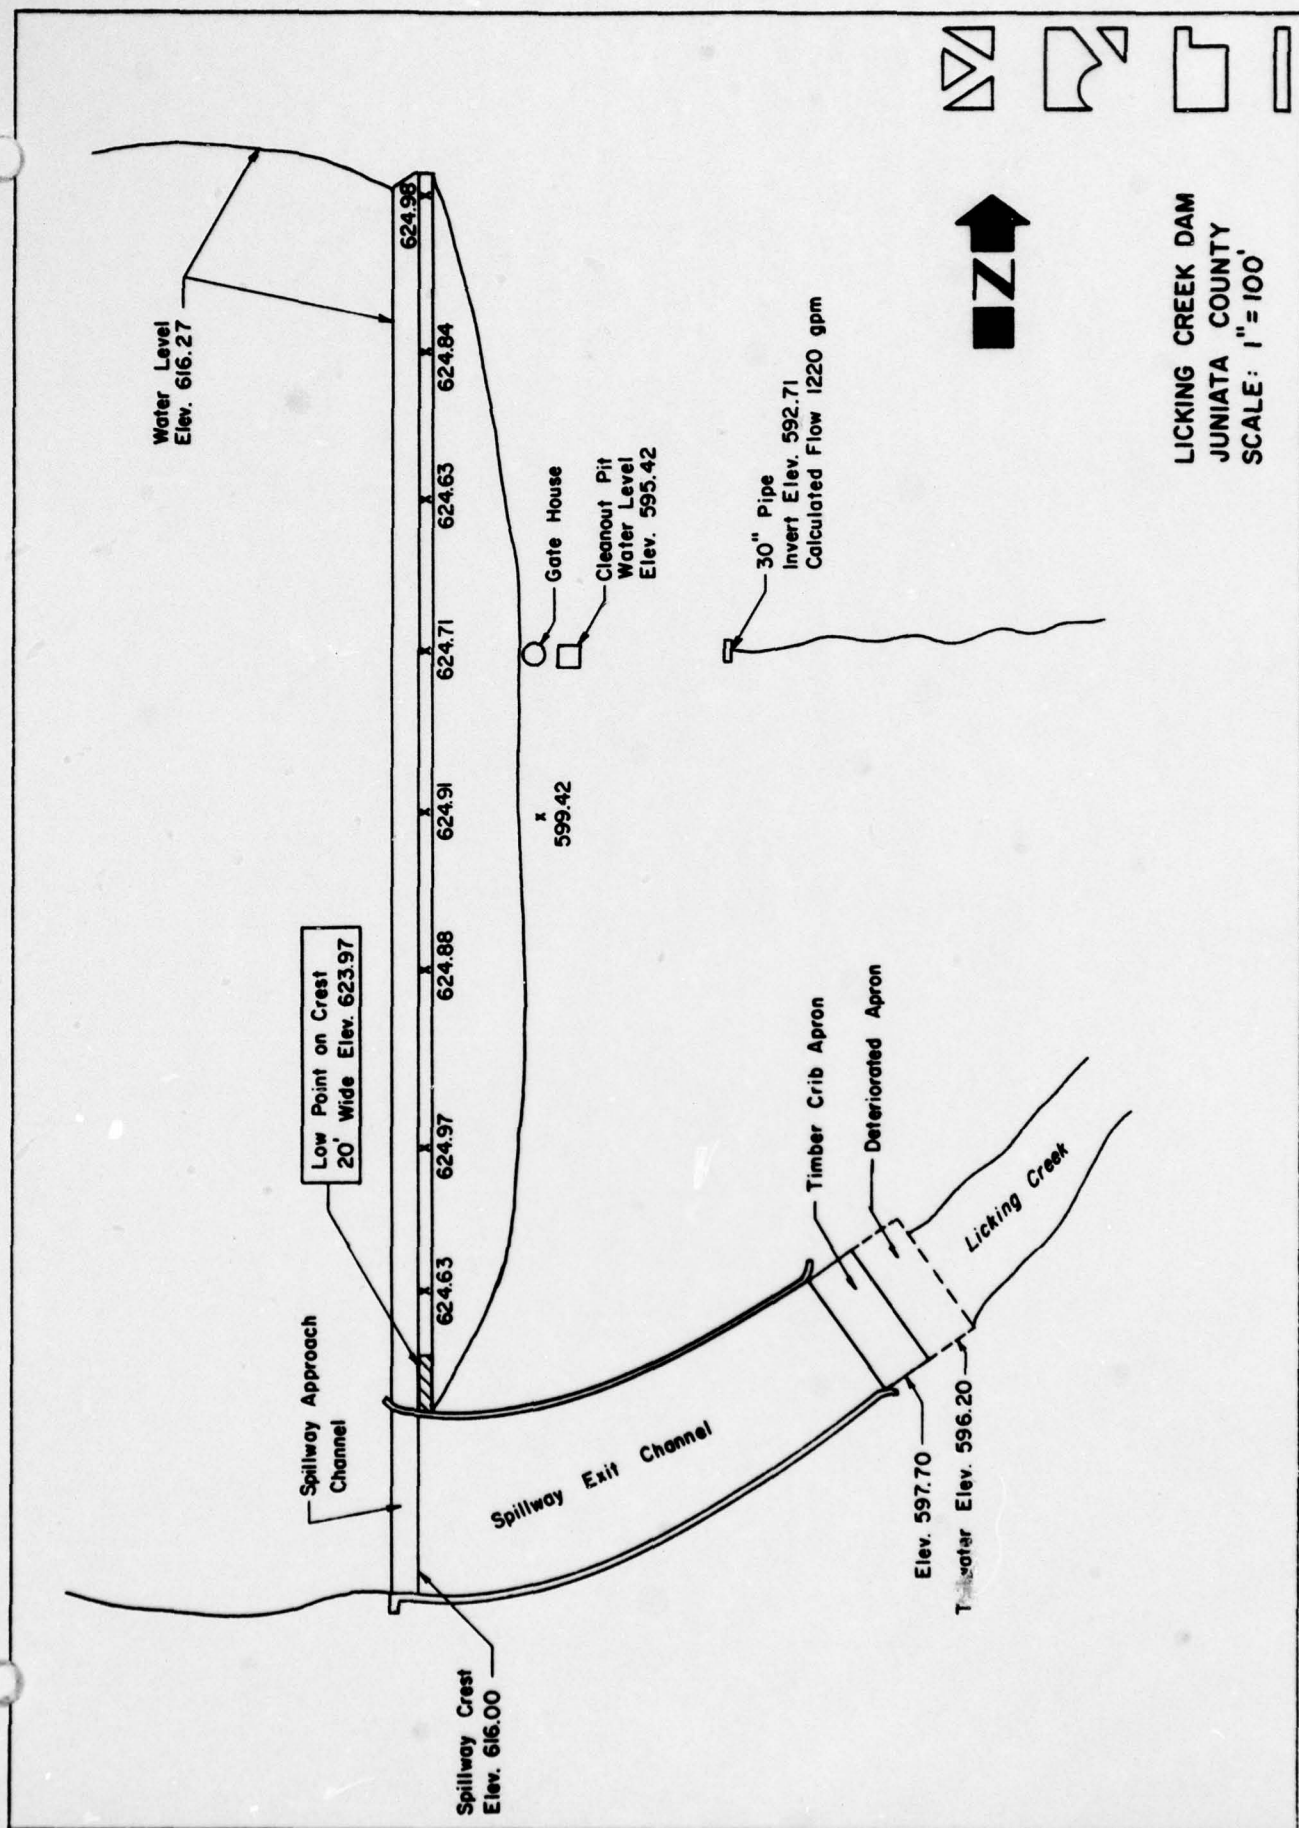
LICKING CREEK DAM
 JUNIATA COUNTY
 SCALE: 1" = 100'

b. Dam. The dam appears to closely conform to the few construction drawings available. From a brief survey conducted during the inspection it was noted that a low spot approximately 150 feet long exists on the right abutment adjacent to the spillway wingwall. This low spot gradually increases in depth toward the spillway. The lowest portion is 0.78 feet deep and extends for 20 feet in length (See drawing on page 7).

A low spot was noted on the dam embankment adjacent to the spillway approach wingwall. This area could easily be filled to the top of dam elevation.

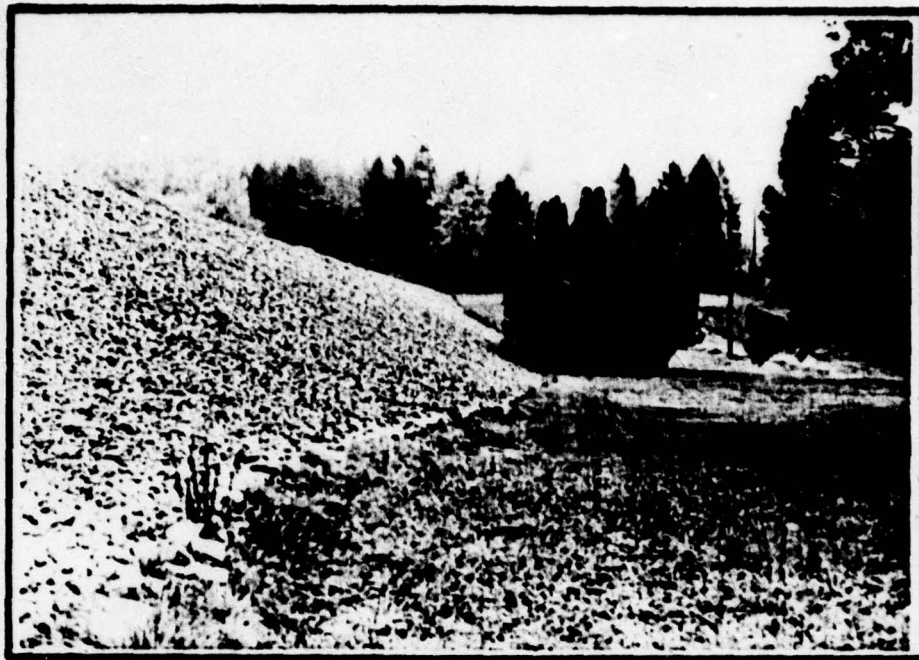
Photograph No. 1

Downstream slope from right abutment toe.

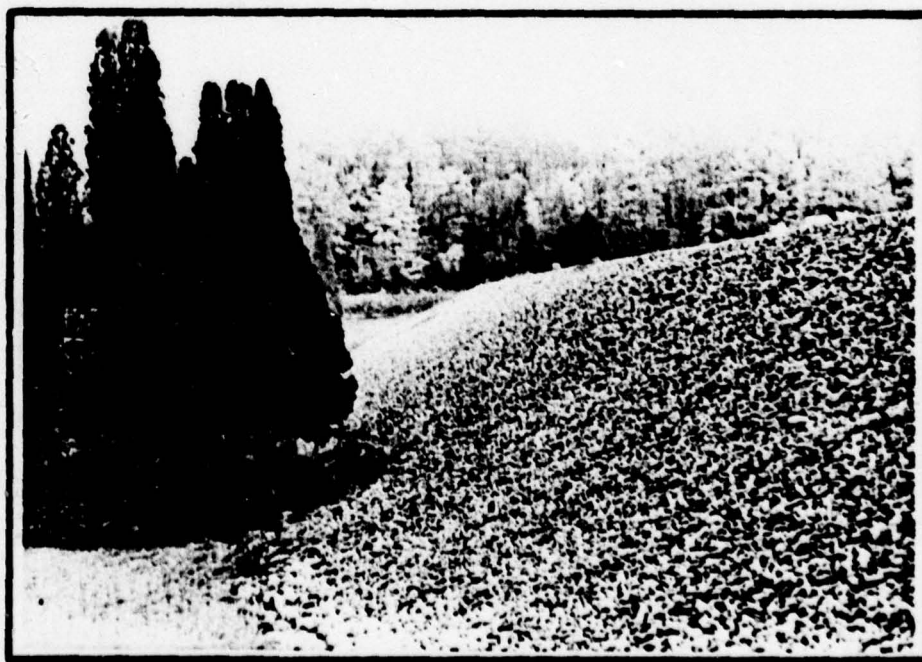
Photograph No. 2

Downstream slope from left abutment toe.

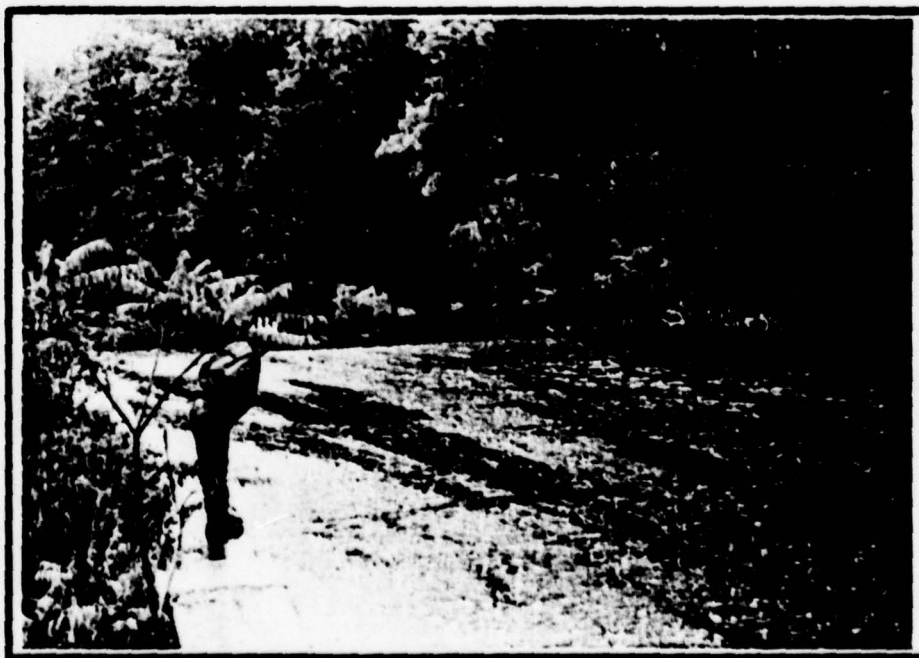
Photograph No. 4

Looking down spillway exit channel.

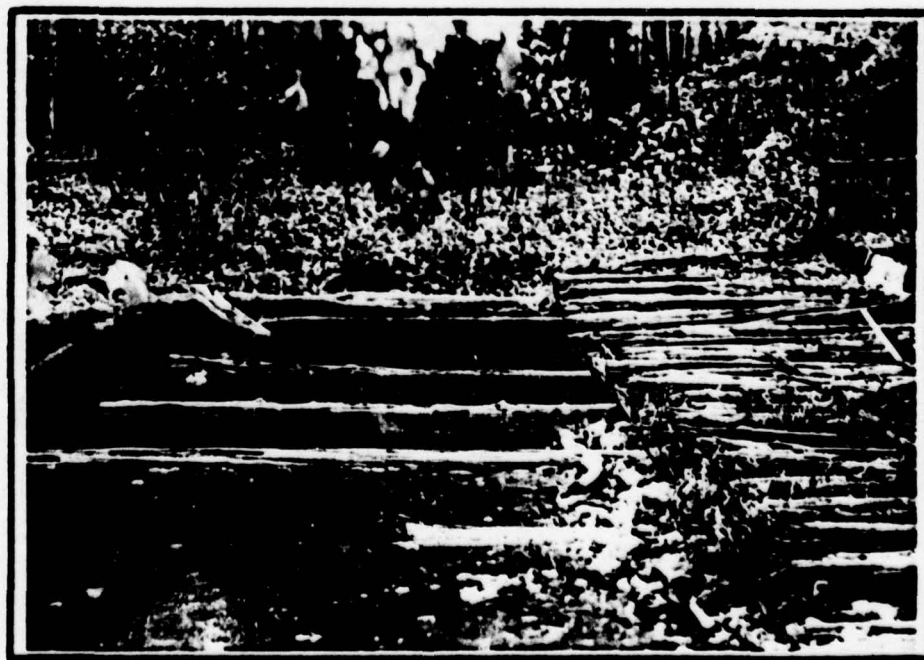
Photograph No. 6

c. Visual Observations. The spillway appeared to be in good condition and well maintained. The timber crib apron located at the spillway discharge is in need of repair.

VISUAL EXAMINATION OF	OBSERVATIONS	REMARKS OR RECOMMENDATIONS
CONCRETE WEIR	100' long broad crested weir. Condition good.	
APPROACH CHANNEL	10' long. Good condition.	
DISCHARGE CHANNEL	Concrete chute. Well maintained. Timber apron at end needs replaced.	
BRIDGE AND PIERS	None.

Timber stilling basin.

5. The deteriorating crib apron at the spillway outlet should be repaired to prevent undercutting of the spillway due to large discharges.

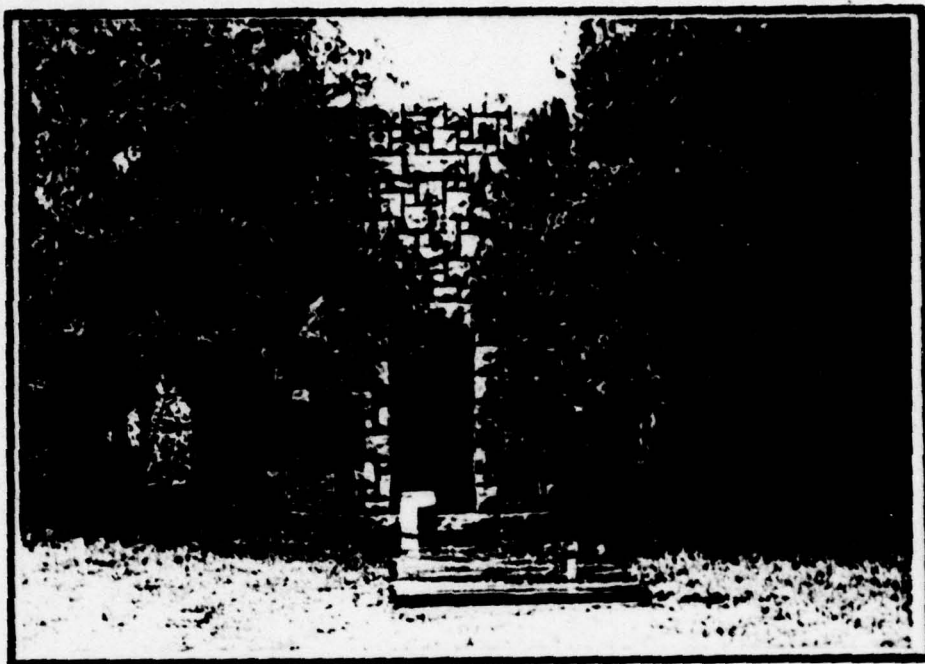
Photograph No. 7

The gatehouse containing the valves for the 16 inch and 30 inch pipes is in very good condition. The valves were not operated during the inspection but are reportedly operable. It was mentioned that it takes three men to open the 30 inch blowoff line. During the inspection the 30 inch line was partially opened. It was estimated to be passing 2.7 cfs.

Gatehouse structure at downstream toe.

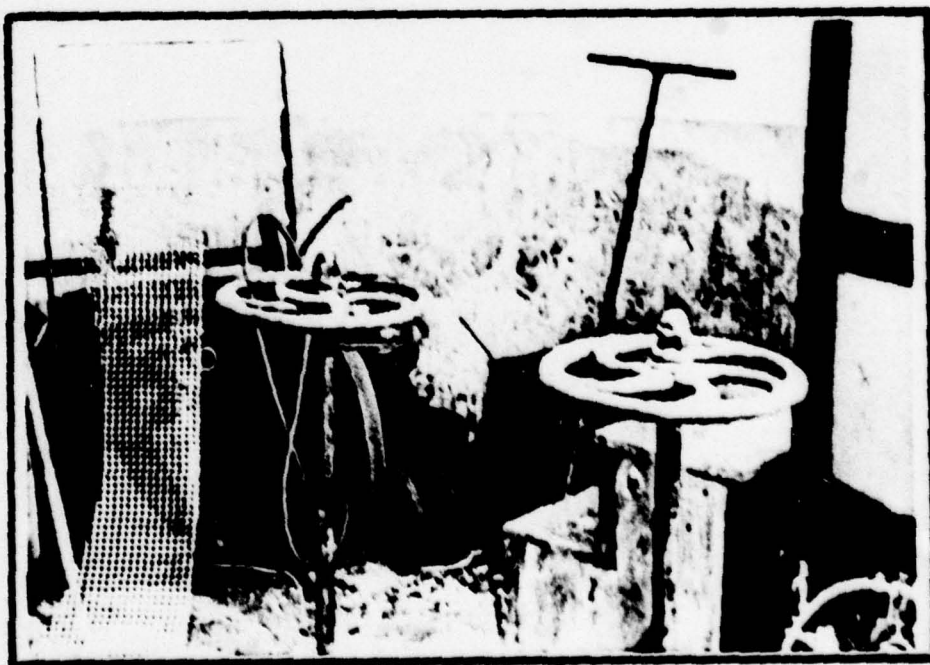
Photograph No. 8

Manual control valves in gatehouse.

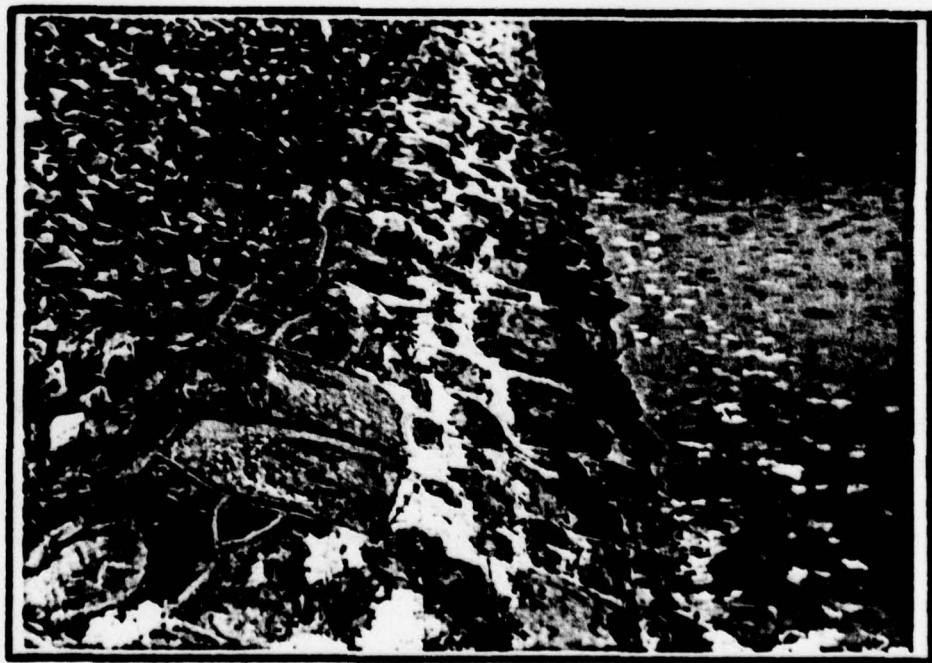
Photograph No. 10

Slope paving on upstream face.

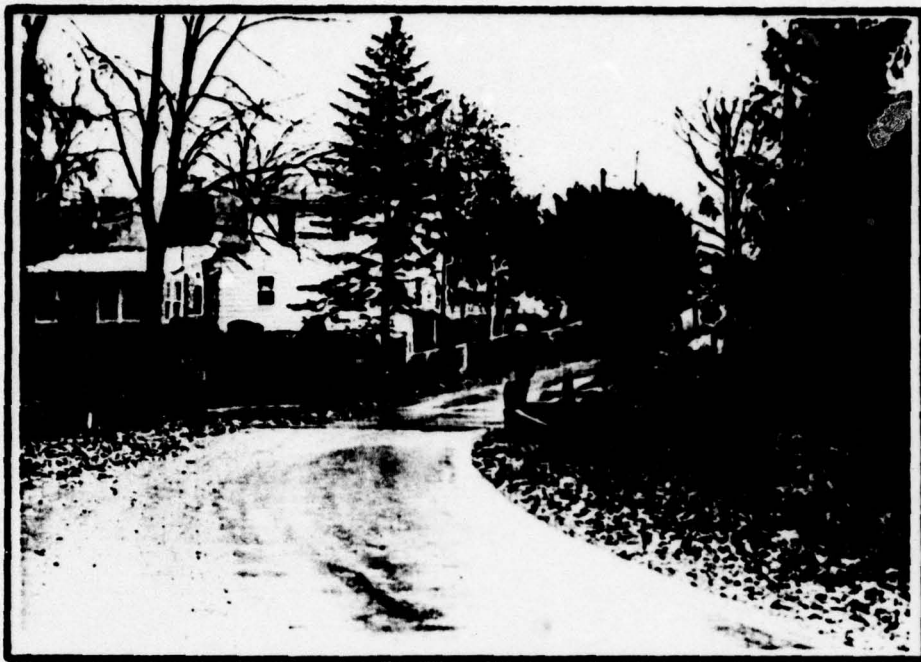
Photograph No. 11

First dwelling downstream.

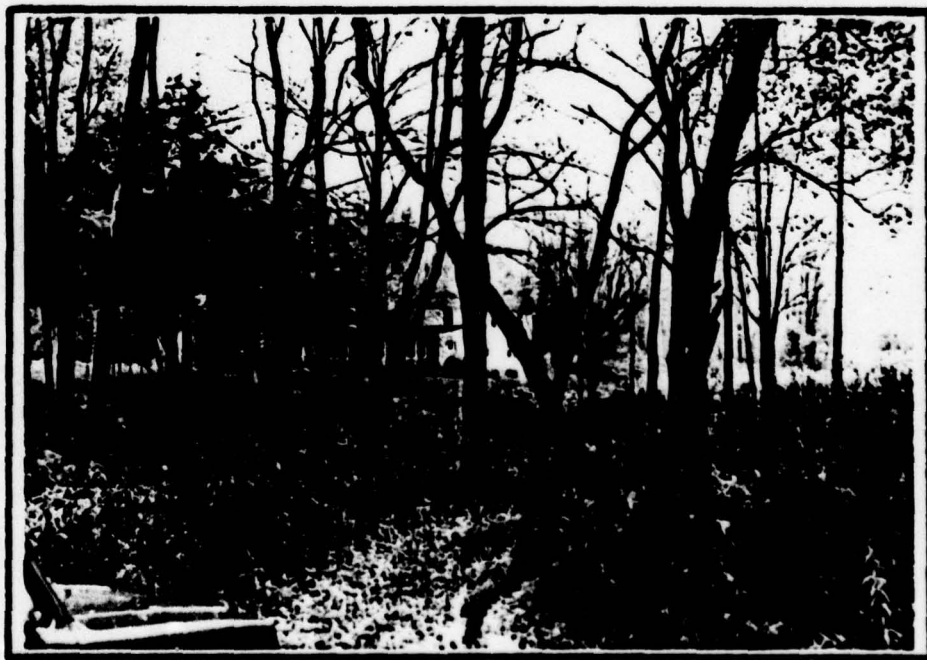
Photograph No. 12

Second dwelling downstream.
